# CYCLONE COATING PROTECTION WITH BELZONA

ID: 7611

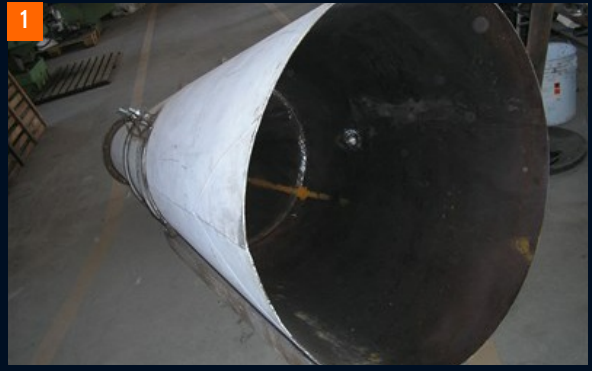
Damaged cyclone

Milled corn material suffers and also adheres on the cyclone surface.

1. Ready for repair
2. Belzona 1812 application
3. Belzona 1812 application detail

Application was carried out in accordance with modified Belzona System Leaflet SHM- 13
