# BELZONA EXTENDS THE LIFE OF MIXING BLADES

ID: 7616

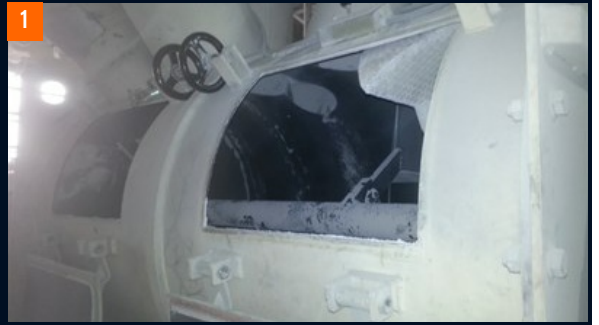
1. Mixing machine
2. Belzona 1812 and 9811 application
3. Anchor after 12 months mixing
4. Anchors after 4 years in service
