# LARGE STORAGE TANK PROTECTED WITH BELZONA

ID: 7618

Crude oil storage tank

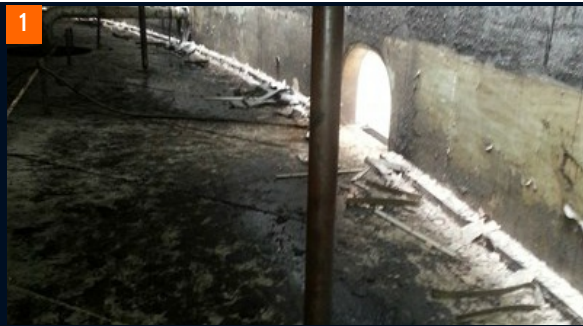
The tank had been in service for twenty years and was suffering extensive corrosion damage

1. Tank after 20 years.
2. Blasting of the basin
3. Visible damages after blasting
4. Belzona 5811 coating applied in 2 layers
