# WEAR PLATES IN ROLLING MILL SECURED WITH BELZONA

ID: 7620

## PROBLEM

An irregular shim is required to secure the wear plates once levelled and bolted in place.

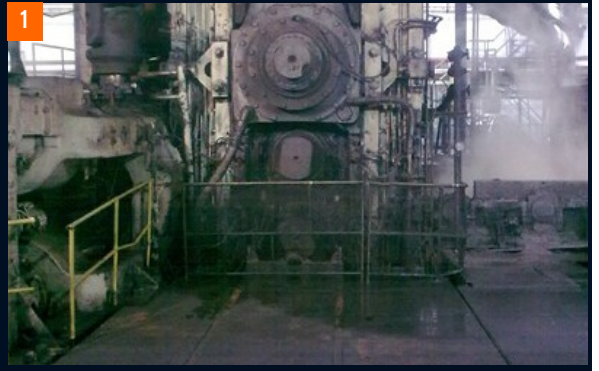
1. The Rolling Mill 2. Testing of the Belzona 1321 injection 3. Wear plate 4. Belzona 1321 injection in action

Wear plates have to be adjusted, tightened and then Belzona 1321 injected to create irregular shim between plate and mill frame. This is a routine application for Belzona 1321 which demonstrates excellent compressive strength required for this application.
