# BRISBANE CITY CENTER STEPS MADE SAFE BY BELZONA

ID: 7625

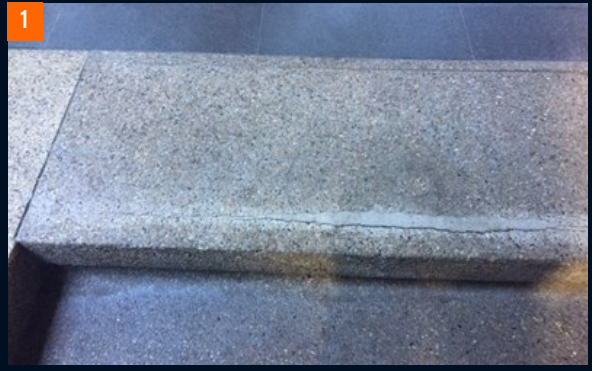
This damaged step was proving rather dangerous as there was a large volume of pedestrian traffic in the area.

An overhanging step in the centre of Brisbane had become worn and caused broken and loose concrete to cause a trip hazard.

1. Broken step
2. Loose concrete removed
3. Former installed
4. Completed repair back in service

The application was carried out in accordance with Belzona System Leaflet FPA-5. Initially, the broken step was demolished, before rebar was drilled and inserted to provide additional strength. The area was correctly prepared and Belzona 4111 was applied into the specially-constructed form-work.
