# BELZONA LEADING EDGE APPLICATION ON A WIND TURBINE

ID: 7626

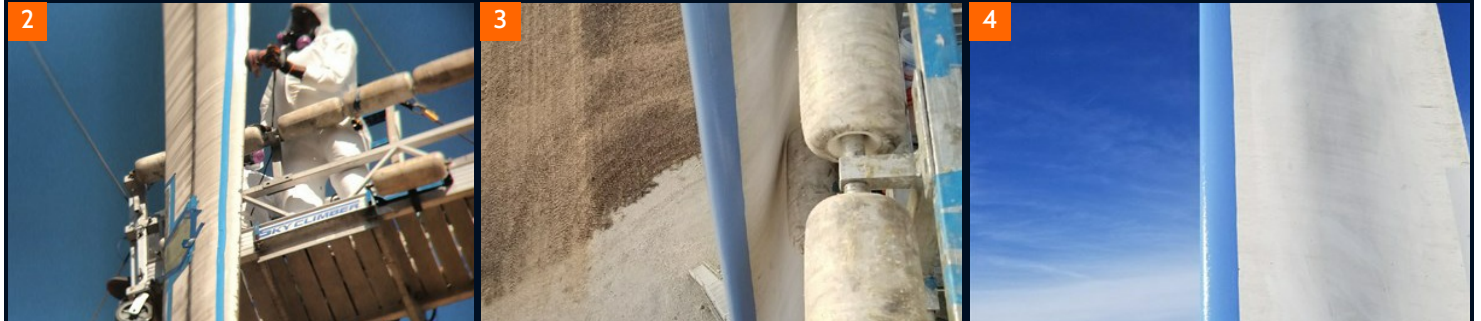
1. Contractors set up in the cable elevator at the turbine tip.
2. Surface preparation, LEP outline, and the coating ready to fill pitting and then coated
3. All of the LEP area now coated and protected with Belzona 1341.
4. Blade ready to be back in service with Belzona 1341 Blue.

The application was carried out in accordance with a modified version of Belzona Know-How System Leaflet FBC-1. The blades were coated on the turbine at the operation site. The pitting and loss of surface on the leading edge was resurfaced in with a filler product and rebuilt to dimensions. The outlined Leading Edge gel coated surface area was sanded down with a mechanical sander with 80 grit sandpaper and cleaned down with a rag and non-residual solvent cleaner. One coat of Belzona 1341 was applied by roller to an average mil thickness of 10-12 mils.
