# BELZONA PROTECTS A STAINLESS STEEL WATER PIPE

ID: 7628

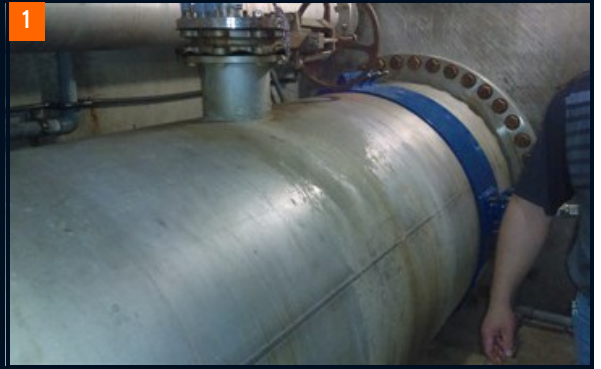
The bleach solution dripped onto the stainless steel pipes over time, causing corrosion and pitting damage. Further damage to the stainless steel pipes could cause a leak, possibly requiring a plant shutdown and leaving thousands of residents without water.

1. 48" and 12" stainless steel pipes, small PVC pipe carrying bleach solution
2. Surfaces cleaned and prepared, Belzona 1151 applied to the damaged area on the back side of the 48" pipe
3. Applying the first coat of Belzona 4311
4. Completed application
