# BELZONA ALLOWS OIL TANKER TO SAIL

ID: 7629

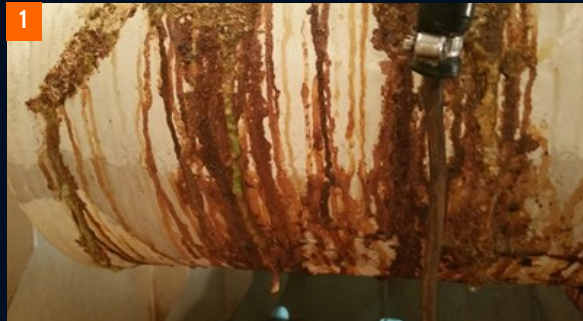
Caused by internal corrosion, the pipe had multiple areas of low metal thickness.

Corroded sea water inlet pipe under the floating line, inside the engine room of an oil tanker. It was not possible to restore/replace the pipe in drydock. In this condition inspector did not give permission to sail.

1. Initial situation
2. Belzona 1221 and plate to fix the leak
3. Surface Preparation
4. Application completed

The application was carried out in accordance with Belzona System Leaflet VPF-11. Following mechanical preparation a small plate was bonded with rapid cure Belzona 1221, then completed with a wrap of the pipe with Belzona 1161.
