# BELZONA SUPERWRAP ALLOWS DRILLING TO CONTINUE

ID: 7630

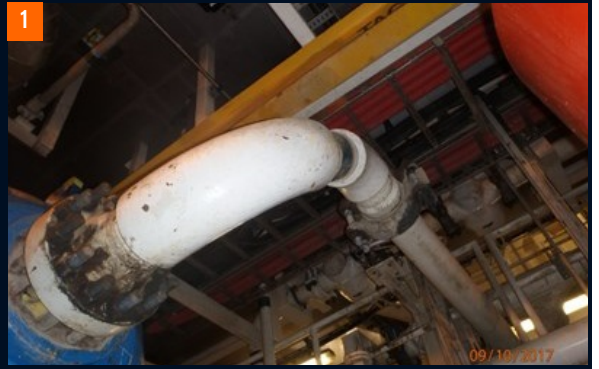
A platform off the coast of Baku had to stop drilling due to wall loss on the HP mud lines. The problem areas were on 3 bend sections.

1. View of Pipe before 21 wraps
2. View of Pipe before 12 wraps
3. View of SuperWrap repair: 21 wraps
4. View of SuperWrap repair: 12 wraps

Due to long lead time fabricating new sections of pipe, Belzona SuperWrap was used to reinstate the required strength to keep the high pressure lines in operation for at least 1 year.
