# ELEVATOR PIT LEAK SEALED WITH BELZONA

ID: 7639

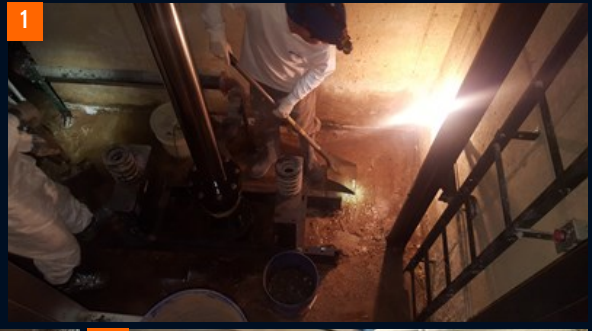
The concrete pit of an elevator shaft had begun to deteriorate and allow water to enter the pit, damage the substrate and corrode the supporting steel structures.

1. Original condition of the elevator shaft. Full of muck, mud, oil, and standing water.
2. Belzona 4131 used to create a permanent seal around the elevator drive shaft.
3. Belzona 4151 applied as a basecoat.
4. Belzona 5231 used as a topcoat.

All surface contaminants were removed and the substrate was power washed and dried. Once dried, the surface was prepared to application requirements and Belzona 4131 was used to rebuild any failures and create a permanent seal around the elevator drive shaft hole. Then a base coat of Belzona 4151 was used to cover the entire floor, sump, and 2" up the walls. A topcoat of Belzona 5231 was then applied within the overcoat parameters of Belzona 4151 and left to cure overnight.
