# BELZONA PROTECTS AUGER MIXER

ID: 764

Screw auger used in production of Calcium Carbonate

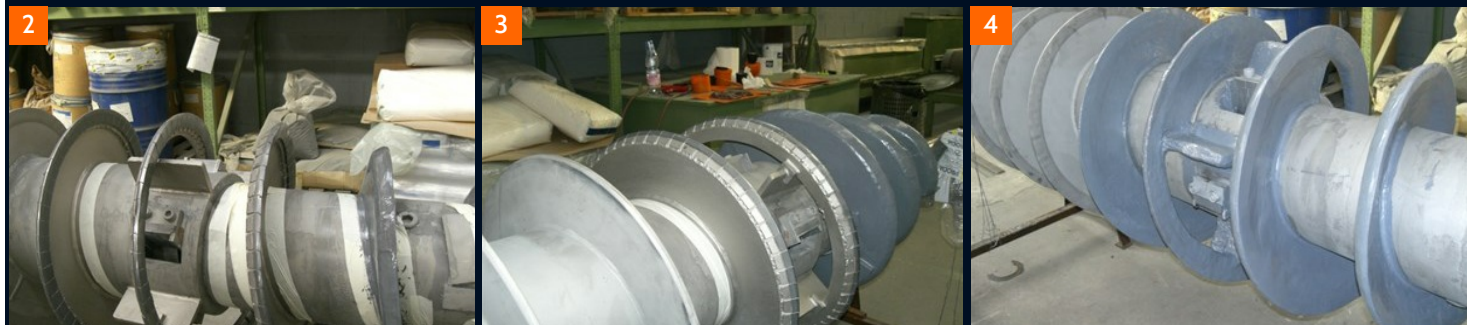
Severe abrasion wears shaft and flights. Hard inserts welded on edges.

1. Auger before refurbishment
2. Grit blasted and application underway
3. Partially coated with Belzona 1321
4. Application almost complete

Application carried out in accordance with Belzona Know-How System Leaflet SHM-14

The Belzona system is renewed after 2 years but protects structure of the auger from the severe abrasion present.

Belzona 1811 (Ceramic Carbide) Belzona 1311 (Ceramic R Metal) Belzona 1321 (Ceramic S Metal)
