# BELZONA INSTALLS A NEW EXPANSION JOINT FOR A SMOOTH RIDE AT AN OPERATING ROOM

ID: 7640

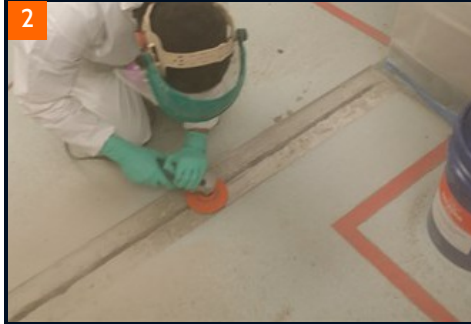
1. The stainless steel cover removed exposing the failing expansion joint material.
2. Scarifying one side to even the joint which was off in some areas by a 1/4 of an inch thick.
3. Finished application.
4. Custom 1/8" thick steel bridge fabricated specific to this application to allow the OR unit to re-open during the curing process.
