# BELZONA HANDLES STRESS CRACK CORROSION AT A JUICING PLANT

ID: 7641

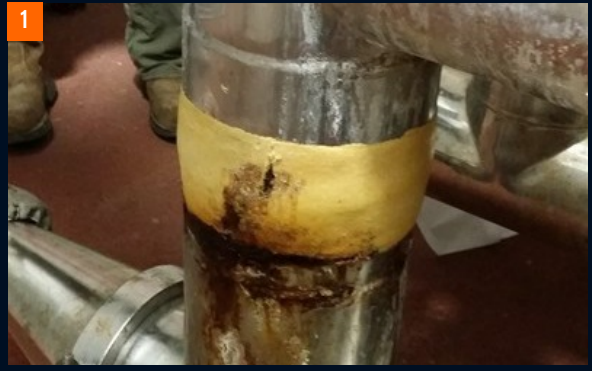
Client called with an ongoing issue of leaking hot water from stress crack corrosion on stainless steel pasteurization pipes. The previous solution, a fiberglass wrapped system, failed after a month of operation. The surface temperature range from 175°F to 250°F max.

1. Previously failed fiberglass wrap
2. Belzona 1511 wrapped over the 1st coat of Belzona 1391T
3. Applying the final coat of Belzona 1391T
4. Two of the four pipes with Belzona solution
