# OXYGENATION TANK REBUILT AND PROTECTED FOR YEARS TO COME

ID: 7642

Oxygenation tank at a wastewater plant. Customer required protection of this tank for years to come. Time was of the essence because rainy season was very close.

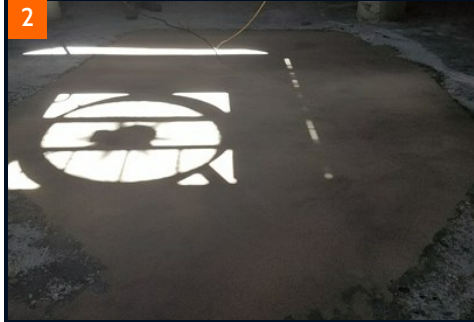
The tank had not had protection for years, and as a result the concrete walls and floors were in a bad shape. Some sections showed erosion as deep as 3'. Large mixer blades had caused a severe erosion the tanks' structure. The time was of the essence because of the rainy season.

1. Damaged Concrete.
2. Concrete rebuilt with Belzona 4124.
3. Concrete coated with Belzona 5811.
4. Belzona Alumina Tiles System installed: Belzona 5811 as a base coat, Belzona 9811 and Belzona 1812 (as a grouting compound).
