# BELZONA REPAIR OF RAIL PRINT INTERFACE ON A SINGLE POINT MOORING TURRET

ID: 7643

Repair of the support flange for the rail on a mooring buoy turret.

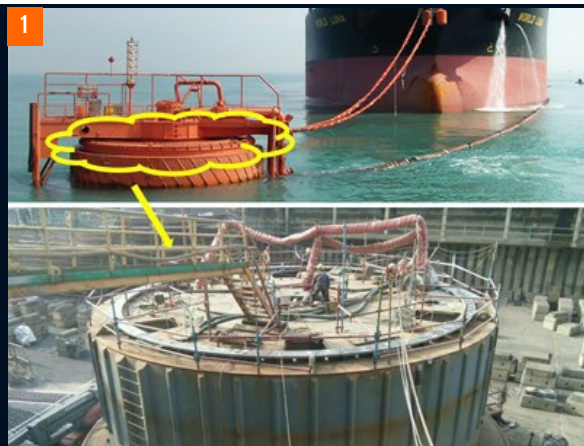
Single Point Mooring Buoy and problem area.

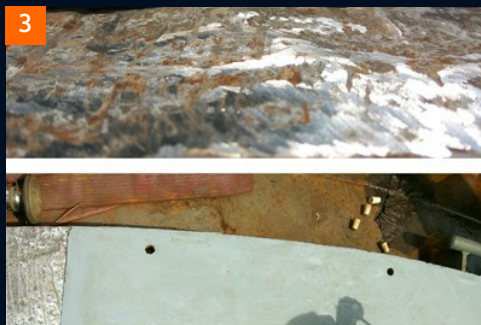
Surface preparation and application.

The surface preparation was carried out by power brushing and grinding deep crossed pattern grooves. Application was done manually with Belzona applicators, plugging the holes where the rails will be bolted to the structure. Leveling of the surface was done with a flat plate segment and side flat guide bars with a width of about 175 mm placed at the rail print area for leveling and for flatness check.

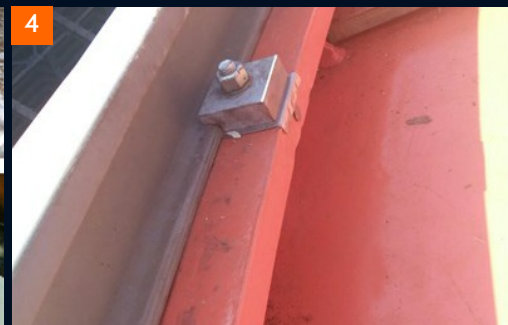
Completed application.

Rebuilding the rail support flange with Belzona 1111 allowed the asset owner to save money and time. Welding would have been much more time and manpower consuming, while machining on site would have been very complicated, time consuming and costly. Apportioning new metal to rebuild the rail print wouldn't have solved the problem since the risk of galvanic corrosion would not have been eliminated. A Belzona 1111 rail print interface could be adopted in new fabricated turrets in order to extend the life span of the asset.
