# NEW TRANE CHILLER PROTECTED WITH BELZONA

ID: 7644

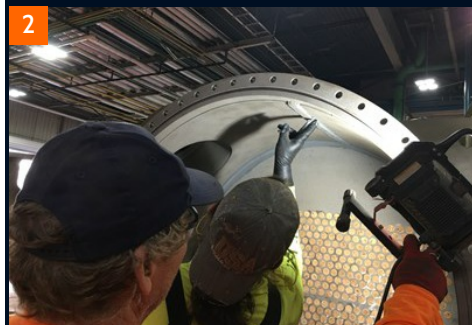
1. Corks were added before blasting. Then the unit was blasted.
2. More corks were added then ground down flush since the copper tubes were flush with the sheet. All seams were sealed with 1121.
3. Care was taken to seal the ends of the inserts so no water could enter during operation and cause rusting from the inside out.
4. Both ends of the chiller and the water boxes were coated and the corks were blown out and the tubes cleaned out to turn over to the owner.
