# BELZONA SAVES A LARGE HOT WATER TANK AT A MEDICAL FACILITY

ID: 7646

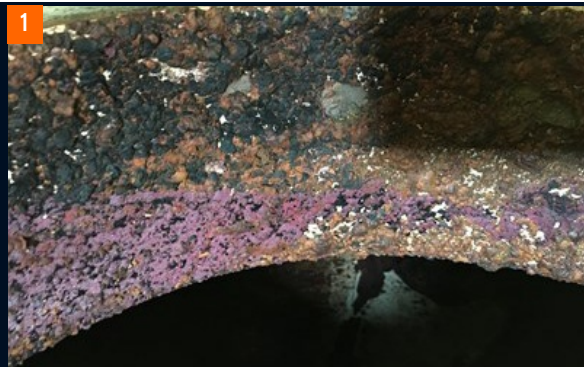
The original tank was very rusted and the original coating was mostly worn off. They didn't even know if the tank could be saved but were willing to try a new coating system. This facility has many residents and they were afraid the tank would fail and there would not be any money budgeted to get a new tank as quickly as they would need it. This was the only tank they had for this purpose.

1. Rim before Belzona restoration.
2. Inside tank before restoration.
3. Rim after restoration.
4. Inside tank during final coat.

The tank was grit blasted with Black Beauty to Belzona's standards. Then two coats of the 5892 were applied. Belzona 5892 was chosen because it could withstand high temperature and could be put back into service quickly. The application was done in accordance with a modified version of Belzona System Leaflet TCC-5.
