# 4311 COATS A SULFURIC ACID TANK AT A CHEMICAL PLANT

ID: 7648

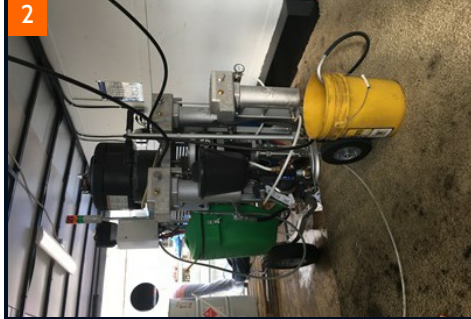
1. This is the tank after blasting with Black Beauty to get the required Belzona cleanliness standard.
2. This shows the pump they used.
3. The spray team about to start.
4. Finished application of 4311.

The contractor used a heated plural component pump to do the application as per Belzona's spray instructions. The application was done in accordance to Belzona system leaflet TCC-5.
