# BELZONA REPAIRS VULCANIZED RUBBER LINED PUMP

ID: 765

Vulcanized rubber lined pump body

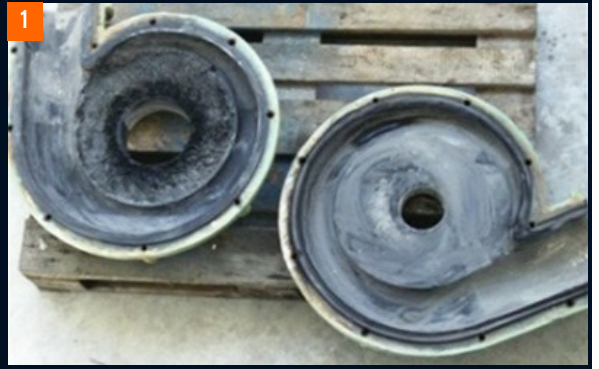
A large area of the rubber had been eroded away.

1. Pump body before application
2. Close up of damaged rubber
3. Upper body after application
4. Lower body after application
