# BELZONA SUPERWRAP II SAVES LEAKING SOUR CRUDE TANK

ID: 7651

A leaking sour crude tank in an oil field.

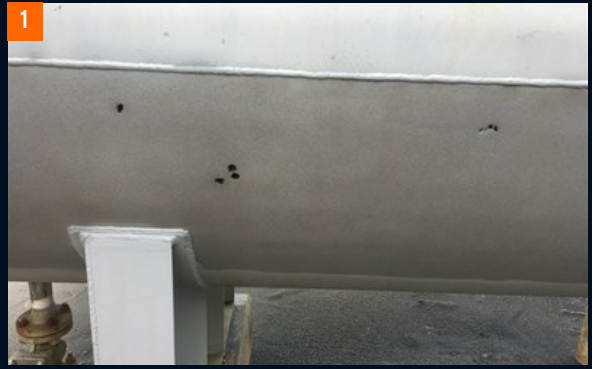
The sour crude tank started leaking and the production had to be shut down. Originally there were 3 holes discovered leaking in the tank. The Customer was afraid blasting would cause more holes along the liquids line. There was no money in the budget for a new tank but they were shut down and had to do something quickly.

1. More than the original 3 holes were discovered after blasting with Black Beauty.
2. Belzona 1111 is being applied to fill the holes and reinforce the area.
3. SuperWrap II is applied by the customer's crew in two coats along the liquids line. Each coat is applied in a different direction.
4. Finished tank after the Customer put the tank back in service.
