# BELZONA RE-COATS A LARGE GOULDS PUMP IN A PAPER MILL

ID: 7652

A large Goulds Split Case Pump that has worked 24/7 in a paper mill for many years.

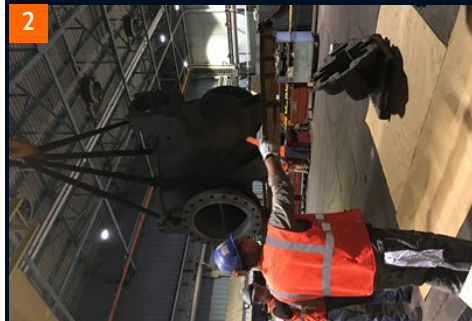
1. Blasting out in the nn-house contractor's blast yard.
2. Bringing in the pump with an overhead crane.
3. Application complete.
4. Application complete.

Old coating was blasted off with Black Beauty to reach the cleanliness profile required by Belzona. Belzona 1311 was applied to smooth out all rough areas. Two coats of Belzona 1321 were applied with brushes. The application was carried out in accordance with CEP-3 and CEP-5 Belzona System Leaflets.
