# A UNIVERSITY CONDENSATE TANKS PROTECTED WITH BELZONA FOR A LONG-TERM SERVICE

ID: 7656

Two new condensate tanks for a university boiler house.

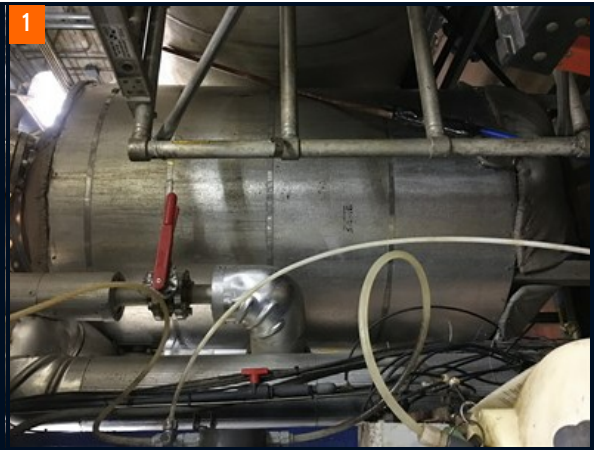
1. One of the two condensate tanks.
2. Application by brush.
3. Spark Test Machine.
4. Spark testing the finished tank.

These tanks were blasted by Sponge Jet method to control dust in this closed environment. Two coats of Belzona 1381 were applied by brush. The product cured overnight and then was spark tested to detect any holidays. The application was done in accordance with Belzona System Leaflet TCC-5.
