# NEW BELZONA COATING FOR TWO SIDE-BY-SIDE CONDENSER TANKS

ID: 7657

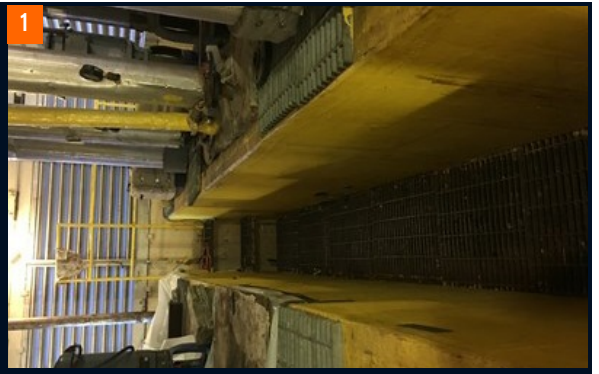
The existing coating in the tanks was having some problems with delamination. The owner wanted them to be coated with Belzona. These tanks held water around 198 F. They had no agitation.

1. Two condenser tanks, side by side.
2. Blasting the tanks using Sponge Jet.
- 3 & 4. Newly re-coated tanks with two coats of Belzona 5892.
