# BELZONA PROVIDES A BULK REPAIR TO A MEAT FREEZER FLOOR

ID: 7662

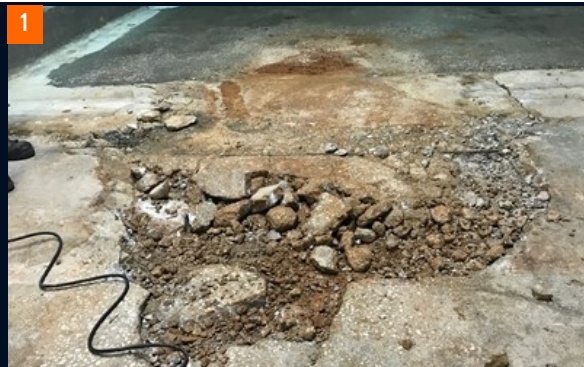
Freezer floors have been under 24/7 heavy forklift operation and freezing conditions for more than 40 years. Some areas needed major overhaul. Major concrete damage was found on floors that are indispensable for plant operation. In addition, some localized repairs were needed all over the place. Turnaround time was also an issue with only 3 days to perform repairs.

1. Condition of the floor after removing covering metal plates
2. Surface preparation on the way
3. Ongoing application (Belzona 4154 and pea-gravel)
4. Finished repair after Belzona 4111 application
