# BELZONA REPAIRS AND PROTECTS AGAINST CHEMICAL ATTACK

Chemicals storage room spill collection trough.

Aviation repair facility, Florida, USA

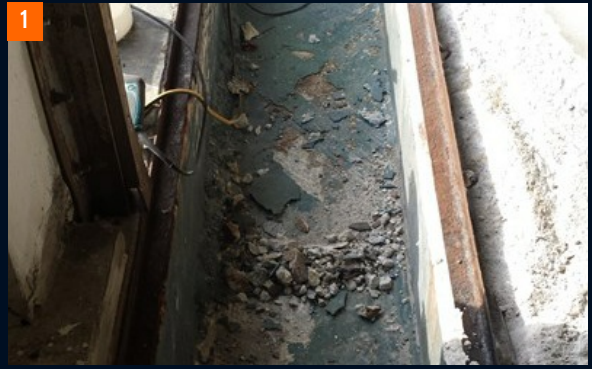
Sulfuric acid and other chemicals were collecting through the years into the trough and severely compromising the integrity of the structure.

1. Trough condition before the repair
2. Surface preparation and walls rebuilt with Belzona 4141
3. Rebuilding and leveling bottom of trough with mixture of Belzona 4151 and Belzona 4131
4. Completed application after two coats of Belzona 4311
