# BELZONA SPRUCES UP WHILE REPAIRS AND PROTECTS AN AIRPORT FOUNTAIN

ID: 7666

International Airport, Florida, USA

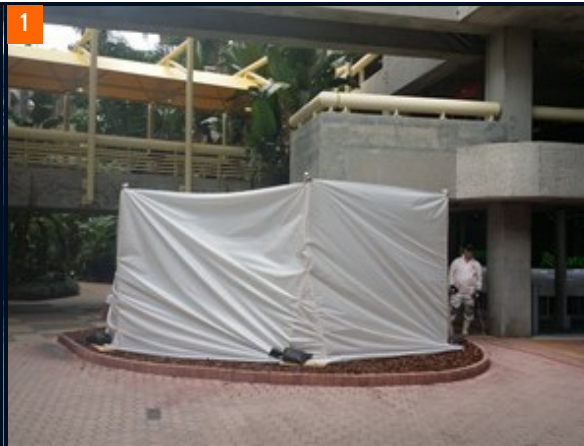
1. Containment for the fountain to keep concrete dust away from the adjacent rental cars.
2. Scarifying the inside of the fountain
3. Applying Belzona 5233 clear
4. Finished application and fountain started 3 days after application.

The surface was prepared by scarifying concrete. Belzona 5233 (Clear) was applied to the rock face around the outside of the fountain. Some cracks were fixed by applying Belzona 4124. The inside of the fountain was coated with Belzona 5812DW (Blue).
