# BELZONA MR7 HOLDING BACK STORM WATER AND KEEPING OFFICES DRY

ID: 7667

## PROBLEM

Storm water drain backing up into the air handler room adjacent to rental offices on the lower level of the main terminal of the airport. This storm/waste water had caused thousands of dollars in damages and they wanted something to prevent it from seeping into the adjacent offices.

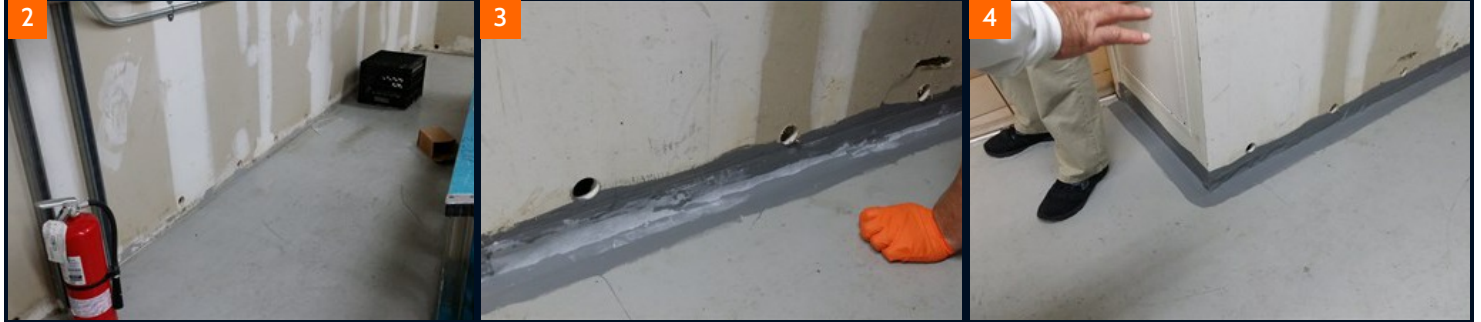
## PHOTOS

Rental car offices flooded with the storm water due to an air handler room drain back up.

1. Storm drain that would back up and flood.
2. Area previously effected by the flooded storm water.
3. First coat of 3121 (MR7) and reinforcement sheet applied and ready for the second coat.
4. Final coat of Belzona 3121 (MR7)

A modified version of Belzona Know-How System Leaflet RPA-8 was used during the application. Belzona 3121 with a reinforcement sheet was applied 3" out from the wall and 3" up the wall.

The application sustained another drain back up a few days later and no leakage occurred into the adjacent offices.
