# MEAT PROCESSING PLANT IN NEED OF BELZONA ON COOLING TOWERS

ID: 7669

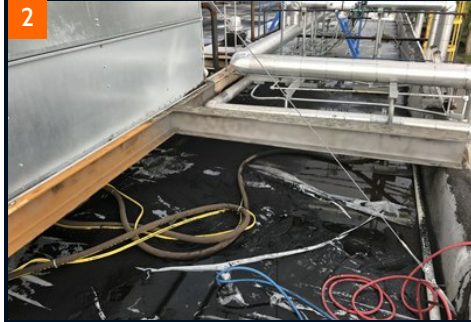
The customer had acquired and installed a brand new cooling tower on an existing corroded framework. Piping system was also corroded.

1. Framework and piping before surface preparation.
2. Ongoing surface preparation using grit-blasting.
3. Framework after application of Belzona 5811 and Belzona 5111.
4. Piping after application of Belzona 3921 and Belzona 5111.

Application carried out in accordance to a modified version of TCC-05. Framework was grit-blasted to NACE 2 Standard. One coat of Belzona 5811 and two coats Belzona 5111 were applied. Some sections of the framework were inaccessible for coating and -in lieu- the access point was sealed with Belzona 3111. Piping system was prepared using power tools. One coat of Belzona 3921 and two coats of Belzona 5111 were applied.
