# BELZONA GRANOGRIP SYSTEM PROVIDES SAFETY AT A MEDICAL FACILITY

ID: 7670

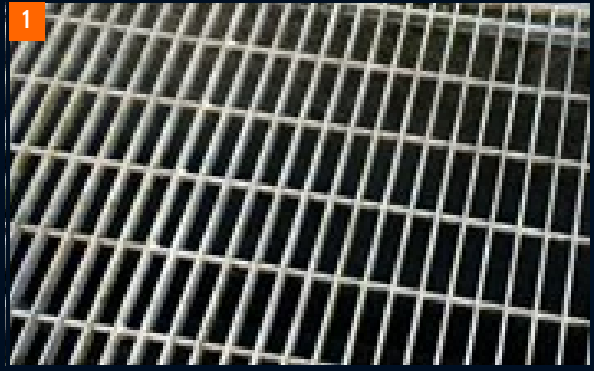
New construction of a medical facility. The plans called for open grates over the sidewalk drains. The building inspector rejected the open grates as a safety hazard, especially for high heel shoes.

1. Open grate - safety hazard.

Determining that the open grates would be a safety hazard and untreated steel would be a slip hazard the engineers called Belzona for a solution. Samples were sent to the building inspector and he chose Belzona 4411 GranoGrip with Belzona 9211 Aggregate.

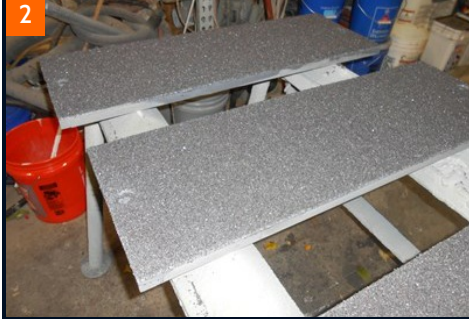
The 12 - 1' x 3' plates were grit blasted in the shop. Belzona 4411 was brush applied and Belzona 9211 pressed in over the whole surface.

2. Twelve steel plates after being grit blasted in a machine shop.

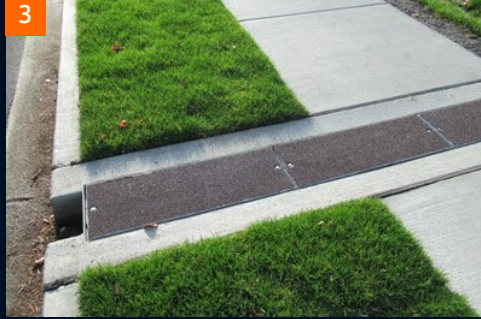
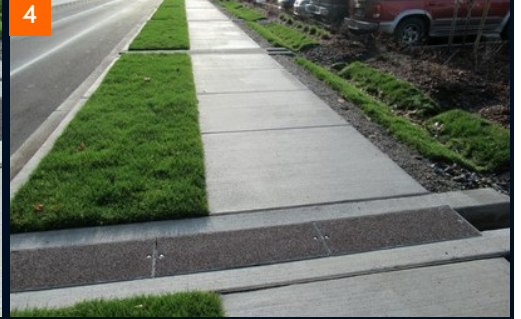
3. & 4. Sidewalk drain covers in place.
