# BELZONA APPLIES A PROTECTIVE SYSTEM ON A GRIT SNAIL

ID: 7671

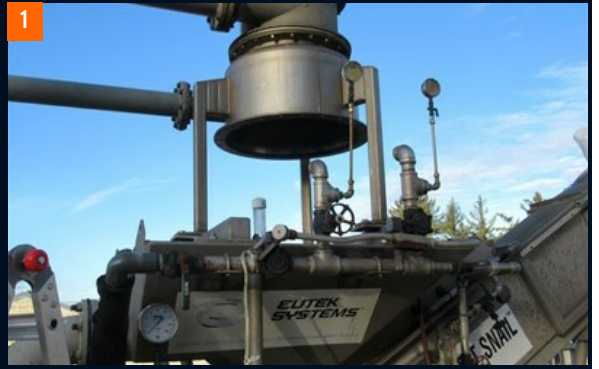
1. Grit Snail
2. Worn area inside grit bowl.
3. & 4. Belzona 1811 (Ceramic Carbide) replaced.

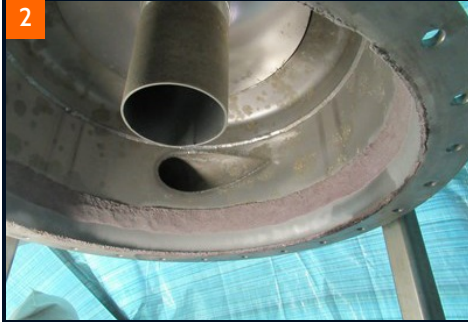
Grit running through the grit removal system wears through the protective coating and the stainless steel housing.

The grit removal system, called a Grit Snail, in a waste water treatment plant malfunctioned. The timer had quit working causing the Grit Snail to run constantly causing the factory installed sacrificial coating to wear prematurely through the coating in to the stainless steel housing.
