# BELZONA SUPERWRAP II SALVAGES SEWAGE TREATMENT PLANT

ID: 7673

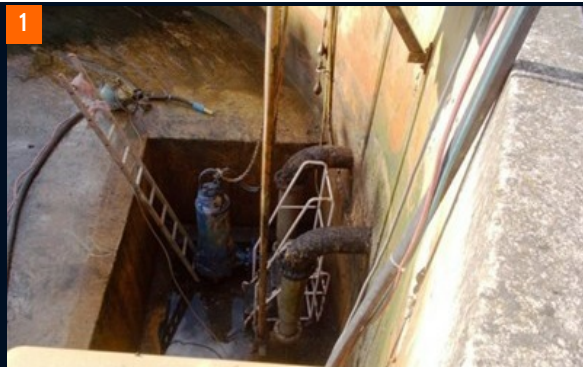
Carbon steel pipe elbows have been suffering over time from external corrosion due to weathering. The Customer required the restoration of metal loss on both pipes whilst adding further protection against future corrosion. The Customer was interested in a compliant composite solution to repair by reinstating the pipe's strength and to protect the pipework from further corrosion.

1. Corroded pipework
2. Extensive corrosion leading to through wall defects
3. Surface was prepared via grit blasting
4. Finish application

The application was carried out in accordance with a modified Belzona Know-How System leaflet VPF-11 for repairing leaks in pipes. The pipework was offline. Three wraps (6 layers) of Belzona SuperWrap II were applied to the repair area according to the design, specifically created for this application.
