# BELZONA KEEPS US NAVY FIRE PUMP READY TO RUN

ID: 7675

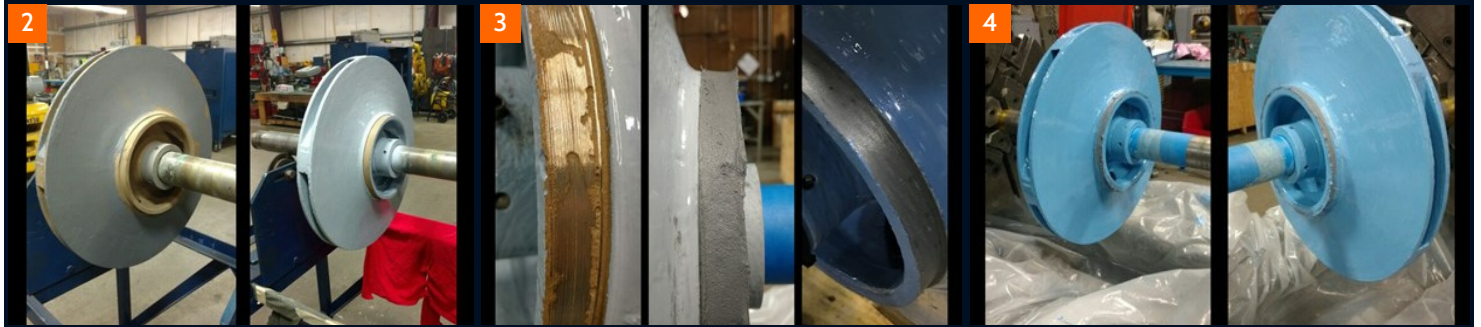
## PHOTOS

Due to lack of frequent use, this fire pump onboard a US Navy ship sits for extended amounts of time with sea water inside of it causing severe corrosion. This makes the fire pump potentially unreliable in case of an emergency.

1. Original condition of the impeller.
2. Belzona 1111 applied to rebuild the damage. First coat of Belzona 1341 applied
3. Belzona 1111 rebuilding the wear rings.
4. Completed application, ready for re-assembly.

Grit blasted to achieve a 3-5 mil profile, and coated with Belzona 1111 to fill in and rebuild the pitting and damage to a smooth clean finish. Allowed to firm up, and then overcoated with the first coat of Belzona 1341. The impeller wear ring was also heavily corroded and was machined down to a rough thread pattern and overbuilt with Belzona 1111 at this time. While waiting for the wear ring application to solidify, the second coat of Belzona 1341 was applied. Finally, the wear ring surface was machined back to the original specifications.
