# BELZONA SUPERWRAP II NOVEL NUCLEAR INSERT

Pump drain and suction pipe within a nuclear power station.

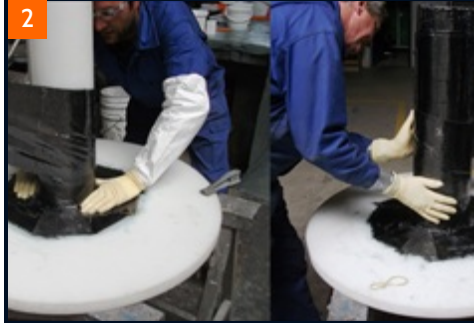
Damp conditions within the area have caused the breakdown of concrete surroundings and corrosion of the pipework, leading to significant loss of wall thickness. The asset owner required the structural integrity of the pipe to be reinstated. The Belzona SuperWrap II system could not be applied externally on the pipework, as it was housed within the concrete foundations, leading to the unique and novel use of the Belzona SuperWrap II system to manufacture an insert.

1. Extensive damage of the pipework and concrete within the pump drain.
2. Manufacturing the Belzona SuperWrap II insert
3. Completed Belzona SuperWrap II insert
4. Final application coated with Belzona 1321

Application was carried out in accordance with a modified version of Belzona System Leaflets TCC-16a and TCC-16b. The pipe insert was manufactured using the Belzona SuperWrap II system, then bonded in using Belzona 1161 before being coated using Belzona 1321 for added abrasion resistance.
