# BELZONA SAVES FISHING BOAT COOLING-WATER CIRCULATING PUMP

ID: 7678

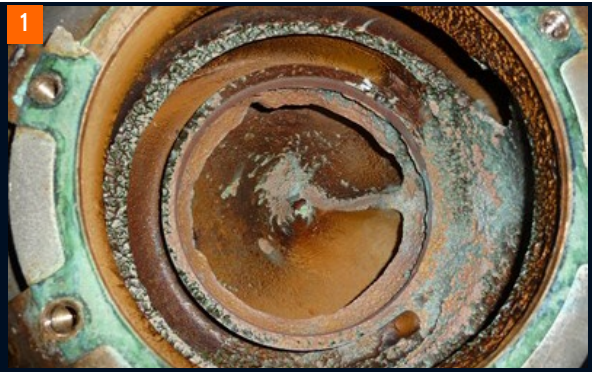
Cooling-water circulating pump, totally damaged by cavitation.

1. Damaged pump casing.
2. Pump repaired and coated.
3. Damaged impeller.
4. Impeller repaired and coated with Belzona.

Application was carried out in accordance with Belzona system leaflet CEP-3. The pump and impeller prepared by gritblasting. Damage in the pump and impeller was rebuilt with Belzona 1311 and coated with Belzona 1321. The impeller was balanced and pump rebuilt with original parts.
