# BELZONA SUPERWRAP REPAIRS CRUDE OIL PIPELINE

ID: 7680

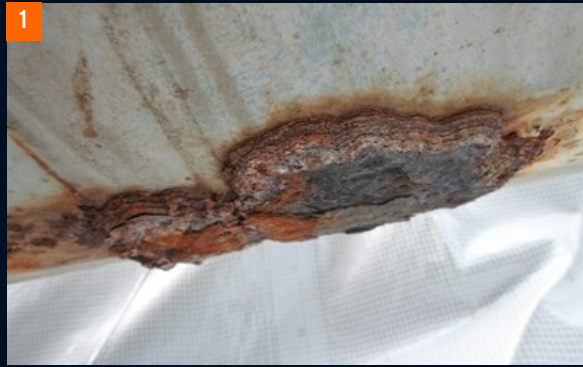
Corrosion Under Insulation had created corrosion scabs to form at the underside of the pipe. Blasting of these scabs was not allowed.

1. Corrosion scab on underside of pipe
2. Blasting of pipeline Picture
3. Application of SuperWrap II
4. Finished Application
