# BELZONA RESTORES ROPE GUIDES

ID: 7682

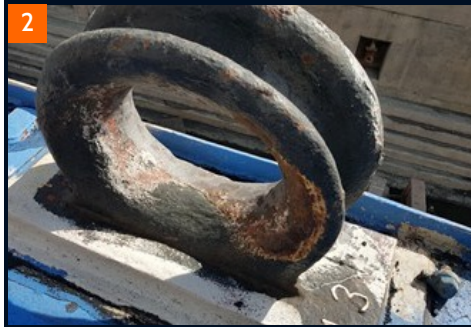
The ship had severe pitting marks and corrosion on the rope guides. This meant ropes could be damaged when sliding over the surface.

1. Potentially damaged ropes
2. Rope guide
3. Application in progress
4. Completed application
