# OLD PUMPS REPAIRED, PROTECTED AND IMPROVED WITH BELZONA

ID: 7685

Dry Dock Facility, BC, Canada

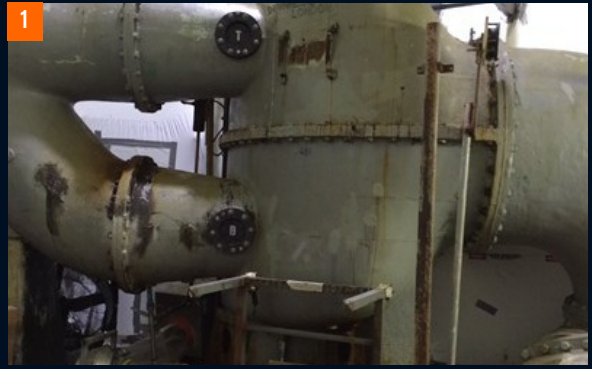
Pumps housing building at a Canadian historic site. 30 ft high pumps.

1. 30 ft high pump.
2. Showing damage from erosion-corrosion.
3. Application of Belzona 1341 Blue in progress.
4. Complete application.

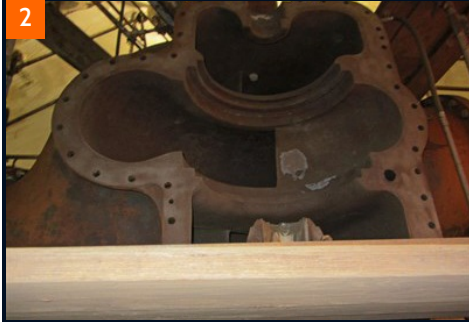
The pumps were damaged by erosion-corrosion due to the salt content in the water they were pumping. Holes had developed in some of the cast iron casings and stuffing boxes also needed major rebuilding. Although the pumps were old, replacing them was not possible.

The application was carried out in accordance with modified versions of Belzona Know-How System Leaflets CEP-1 and CEP-3. Belzona 1121 was used to rebuild and repair the eroded surfaces. Belzona 1341 was used to improve the pumps performance. Due to the large size of the pumps and related inlets and outlets, it was decided to blast in stages and then protect with Belzona 1341. This was followed by a skim coat of Belzona 1341/1121 mixture to fill in most of the lower depressions. The remaining voids were filled with Belzona 1121. The units received a final brush blast before 2 successive coats of Belzona 1341 grey and blue were applied.
