# BELZONA 3111 SUCCESSFULLY HANDLES AN INTRICATE DESIGN OF A CHURCH DOME-SHAPED ROOF

ID: 7687

Church, Virginia, USA

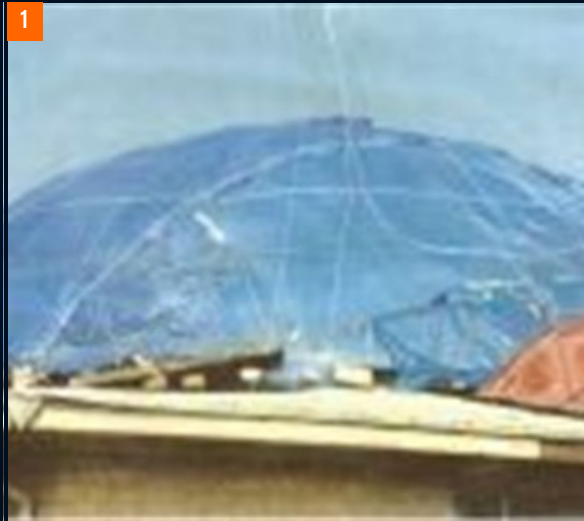
1. Image of the original roof repair back in 1980s.
2. View of one of the domes, showing intricates of the roof design.
3. Complete application.

The entire roof area was pressure washed. All the metal repairs were conducted using Belzona 1121. Belzona 3921 was applied to two (2) areas – each 20' x 40' and one (1) area – 15' x 40' and over metal repair areas. During the overcoat window of Belzona 3921, Belzona 3111 in white was applied at 10 mils thick. Belzona 9311 was wetted out and fully embedded into the base layer of Belzona 3111. Within the overcoat window of the base coat of Belzona 3111, a top layer of Belzona 3111 in white was applied at 6 mils thick.
