# BELZONA EXPANSION JOINT REPAIR HELPS A COAL MINE STAY ENVIRONMENTALLY COMPLIANT

ID: 7688

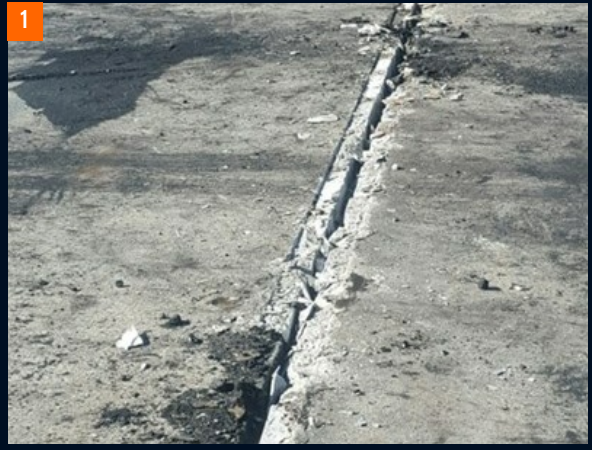
1. Removal of nosing and damaged concrete. 2. Concrete restoration of Belzona 4131. 3. Backer rod inserted prior to an application of Belzona 2211. 4. Expansion joint repair complete.

The repair area was pressure washed to remove all coal dust in and around the joint. Then, the metal nosing, all old rubber and other previously used joint materials were removed and the concrete areas were re-cleaned. Concrete areas were leveled by means of manual grinding. Belzona 4131 was used to build up the damaged concrete. Once Belzona 4131 was applied, this area was not accessible for any traffic until the following day, when Belzona 2211 was mixed and applied with the use of form boards and a backer rod.
