# BELZONA 1111 RETURNS PROPULSION UNIT ON A TOWBOAT BACK TO SERVICE

A towboat propulsion unit.

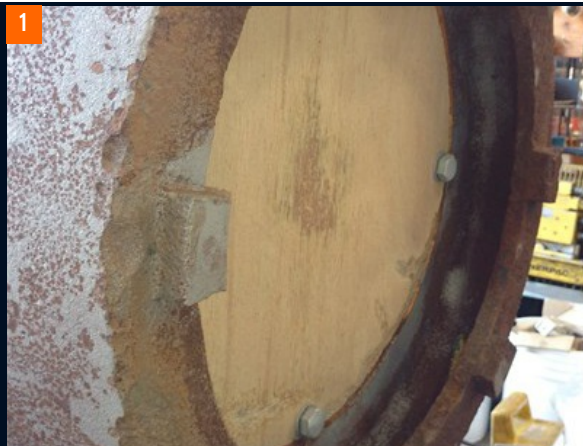
Erosion of the steel on this propulsion unit was getting fairly deep in some parts.

1. Original condition of the propulsion unit showing the corrosion and loss of material.
2. Application of Belzona 1111 complete.
3. Belzona 1111 sanded down to the correct profile, and grit blasted for the application of Belzona 1331.
4. Applying Belzona 1331.
