# GRAND STAIRCASE OF A FUTURE HOME OF A HISTORIC MUSEUM RESTORED WITH BELZONA

ID: 7694

Pre 1920 cast-iron grand staircase.

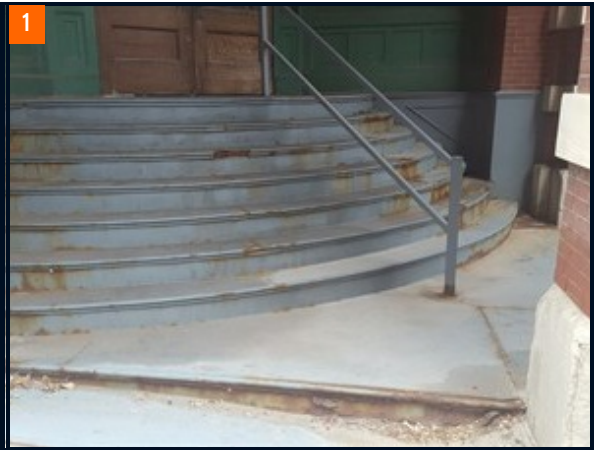
The original build grand staircase made from pre-1920 cast-iron had severe rust and multiple failures. It was a tremendous eyesore and in some areas impassible.

1. General view of the staircase showing damage.
2. Stair nosings rebuilt with Belzona 1211 and steel rods.
3. Two coats of Belzona 5231 loaded with Surefoot Aggregate on walking treads applied.
4. Belzona 5233 applied as a top coat for UV-stability.

The application was carried out in accordance with a modified version of Belzona Know-How System Leaflet FPA-5. Since the application was taking place on a very busy street with heavy foot traffic, a containment area was built to contain the dust from blasting. The substrate was blasted off to bare metal. Once the media blasting was completed, 1/2" iron rods were installed to repair the step noses and cold bond metal plates where the original staircase had corroded away. Then, the entire staircase was coated with Belzona 5231. The second coat was loaded with an anti-slip surefoot aggregate and applied to all walking surfaces. Once Belzona 5231 cured, a topcoat with Belzona 5233 was applied.
