# BELZONA COMPOSITE FERRY WRAP

ID: 7698

Ferry Pipe

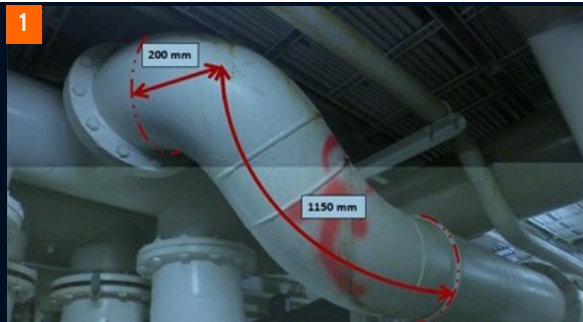
Suffering from external corrosion

1. Damaged pipe
2. Belzona 1121 wrap in progress
3. Composite Wrap complete
4. Completed application
