# BELZONA REFURBISHES 128 STAINLESS STEEL PIPE FLANGES

ID: 77

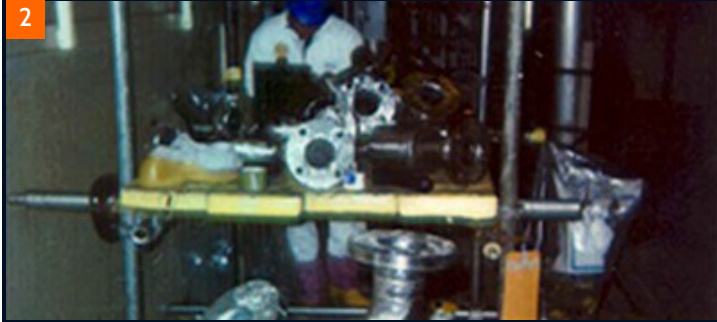
The 3" diameter stainless steel piping suffered from micro biologically induced corrosion (MIC) and corrosion from brackish water.

1. Part of the service water system containing the stainless steel piping
2. Some of the 3" diameter stainless steel spools being prepared
3. Former being used to apply uniform thickness of Belzona 1111 to the corroded flange faces
