# BELZONA ENHANCES HOSPITAL STEPS

ID: 7701

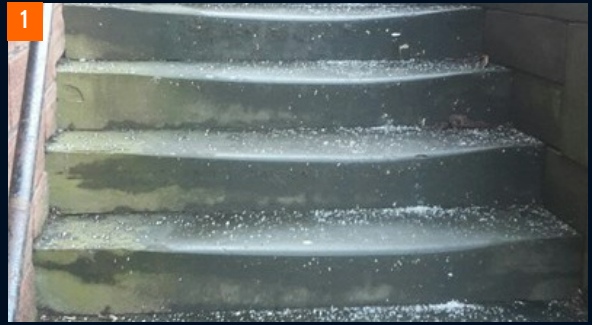
A potential slip hazard had been noted on several sets of sandstone steps. Due to the enclosed area it was often damp or icy in the winter. A durable long lasting solution was required to ensure the slip hazard could not reoccur in the future.

1. Slippery steps before
2. Finished application
3. The steps revisited 7 years after the application

The steps were marked out & prepared using a floor grinder. Belzona 5821 was then applied as a 1 coat system. Immediately following this Belzona 9211 aggregate was blinded into the coating & tamped down.
