# BELZONA REPAIR AND COATING INTERNAL SURFACE OF ROTOR CAN OF PREHEAT UNIT AND REPAIR SHAFT OF COOKER UNIT

Repair and coating internal surface of rotor can of preheat unit and repair shaft of cooker unit.

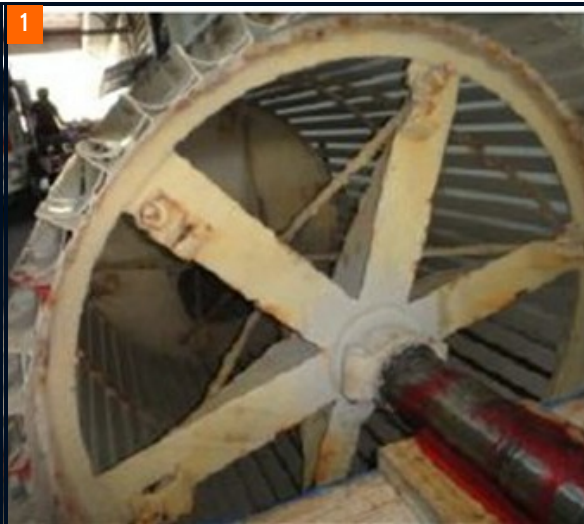
The damage area cause by erosion and corrosion

1. The rotor damage area cause by erosion and corrosion
2. Damage shaft surface at cooker unit
3. Application complete with Belzona 1391S for rotor
4. Application complete with Belzona 1111 for shaft

1. Carbon steel surface will be prepare by copper slug to give a minimum depth at 75 microns and surface cleanliness by Sa 2.5
2. Clean and brush away any loose contaminate, cleaning with vacuum cleaner machine then cleaning the surface with MEK.
3. Apply two coats system of Belzona 1391S Ceramic HT at dry film thickness 500 microns.
