# BELZONA REPAIR AND COATING INTERNAL SURFACE OF MULTIMEDIA FILTER TANK AND ACTIVATED CARBON TANK.

ID: 7710

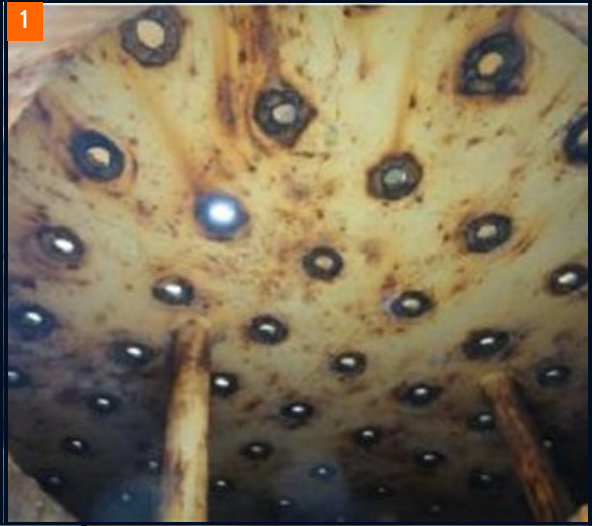
Corrosion found at internal surface of multimedia filter tank

1. Corrosion at internal surface of multimedia filter tank
2. Corrosion at internal surface of activated carbon filter tank
3. Repaired pitting damage area with Belzona 1121
4. Apply second layer with Belzona 5811

1. Carbon steel surface will be prepare by grit blasting with copper slag to give a minimum depth at 75 microns and surface cleanliness by Swedish standard Sa 2.5
2. Clean and brush away any loose contaminate then cleaning the surface with MEK.
3. Apply first coat with Belzona 5811 immersion grade at dry film thickness 200-250 microns.
4. If find pitting damage area repair with Belzona 1121 Super XL Metal.
5. Apply second coat with of Belzona 5811 immersion grade at dry film thickness 200-250 microns.
