# BELZONA REPAIR AND COATING INTERNAL SURFACE OF WIL TRAY MACHINE

ID: 7711

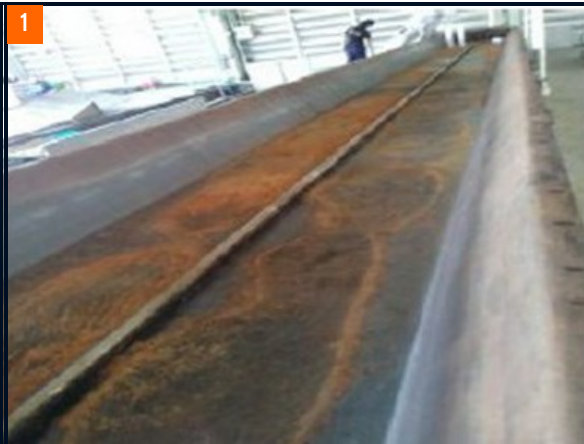
Corrosion at internal surface of wil tray machine.

1. Corrosion found at internal surface of wil tray machine.
2. Apply first layer with Belzona 5892
3. Repaired pitting damage area with Belzona 1121
4. Apply second layer with Belzona 5892
