# POTABLE WATER TANK REPAIRED WITH BELZONA COMPOSITE PATCH STANDS THE TEST OF TIME

ID: 7715

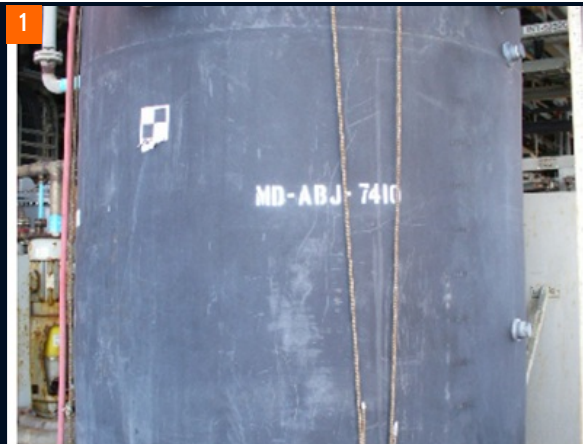
A hairline crack/leak developed on an HDLPE potable water tank on a major deepwater drilling/production platform.

1. Potable water tank overview
2. Location of the leak (a tiny wisp of water pushing out)
3. Belzona composite patch repair completed
4. Belzona composite patch repair holding 1 year later

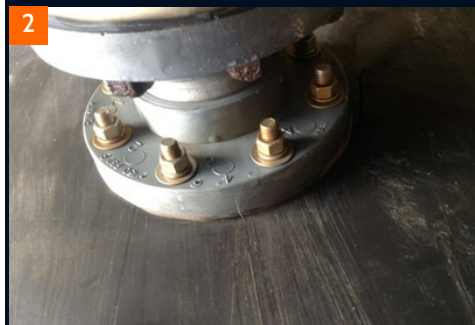
UV Damage and possible loading forces to the HDLPE polymer tank resulted in a hairline crack above a 4" flange. Replacement of the tank was several years away still and the repair method had to be compliant with potable water standards.

The application was carried out in accordance with Belzona Know-How System Leaflet TCC-1 with a composite patch consisting of Belzona 1111/9341.

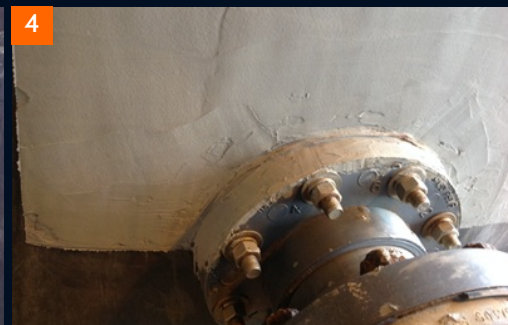
This application is still holding well over a year later, saving this platform from having to complete a costly replacement prior to the scheduled outage. This repair method has become a standard and they keep contingency repair kits on board at all times.
