# BELZONA REPAIRS VOITH SCHNEIDER UNIT

ID: 7722

## PROBLEM

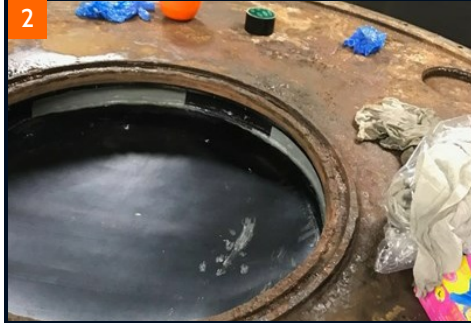
Erosion/corrosion damage meant the unit no longer functioned correctly. Replacement of the unit would total around £120,000

A Voith Schneider propulsion unit was experiencing erosion/corrosion from sand/silt & sea water in service.

1. Voith unit in blast booth
2. Close up of metal loss
3. Sealing face built up
4. Machining of product

The face of the unit was first grit blasted to SA2.5 & 75 microns. The face of the casing was then built up with Belzona 1311 before being overcoated with Belzona 1321. The inner bore was a sealing face, it was built up with Belzona 1311 & then machined down to a close tolerance.
