# CIP BUND COATING

ID: 7726

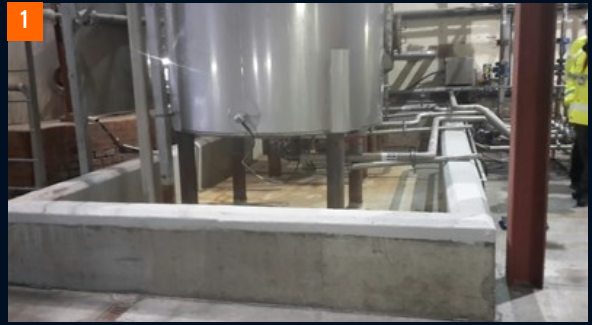
1 - overview of the bund 2 - failed GRP lining showing cracks 3 - Two coats system of Belzona 5811 applied to the concrete & onto the tank legs 4 - completed application

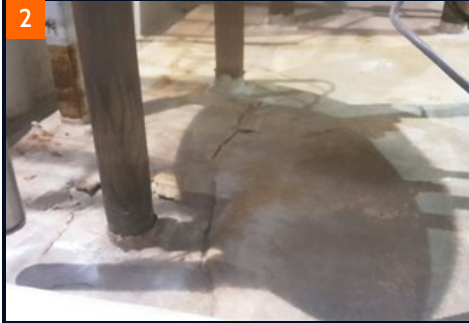
A CIP chemical bund had a GRP lining in place. This lining had started to break down & de-laminate on large areas of the bund.

Application was carried out in accordance with Belzona system leaflet TCC-15. The failed lining was removed & the concrete was prepared with floor grinders. The walls were then filleted with Belzona 4131 Magma screed. Two coats of Belzona 5811 Immersion Grade were then applied to provide corrosion protection.
